## CASE STUDY:

### CRITICAL PIPELINE REHABILITATION UNDER THE GAUTRAIN BRIDGE, PRETORIA An ASOE Pipeline Rehabilitation Project

**Asset:** 250mm Potable Water Pipeline

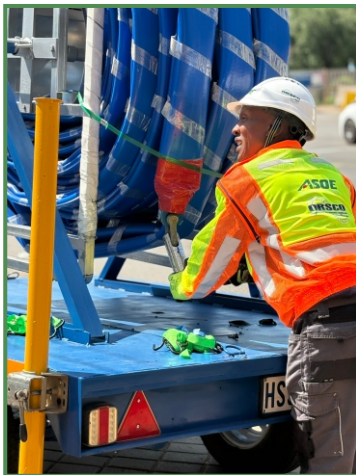
Orsco was engaged by the Tshwane Municipality to assess and address severe issues within a 250mm potable water pipeline.

- **Severe Deterioration:** Initial pre-inspection confirmed the pipeline was heavily corroded and rusted, leading to persistent and unmanageable leaks.
- **Inaccessibility:** The pipeline's location, running directly underneath the critical Gautrain railway bridge and adjacent to the heavily utilized Loftus Versfeld Stadium, made repairs via traditional excavation impossible. Digging would have required extensive traffic management, costly infrastructure support, and a projected timeline of one to two months, severely impacting municipal services and public transport.

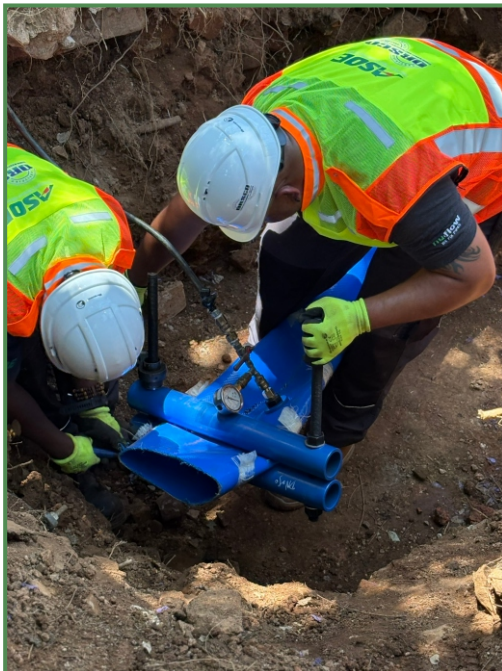
- **Rapid Completion:** The entire rehabilitation project, from initial preparation and cleaning to final liner curing and commissioning, was completed in one week.
- **Minimal Disruption:** The trenchless method eliminated the need for disruptive excavation, ensuring the integrity of the Gautrain bridge structure was maintained and traffic flow was minimally affected.
- **Long-Term Value:** By installing a durable, non-corrosive liner, Orsco provided the municipality with a renewed pipeline, for 50 years, thereby eliminating future maintenance and leakage costs associated with the old pipe.
